WATER UNDER THE BRIDGE

In May 2018, Risanamento Fognature relined a steel water pipeline anchored under the Academic Bridge in the centre of the historic Venice. The challenging trenchless project was part of a larger operation to protect the bridge, which is a popular tourist attraction, featuring some of the most icon views of the city.

PIPELINE RESTORATION

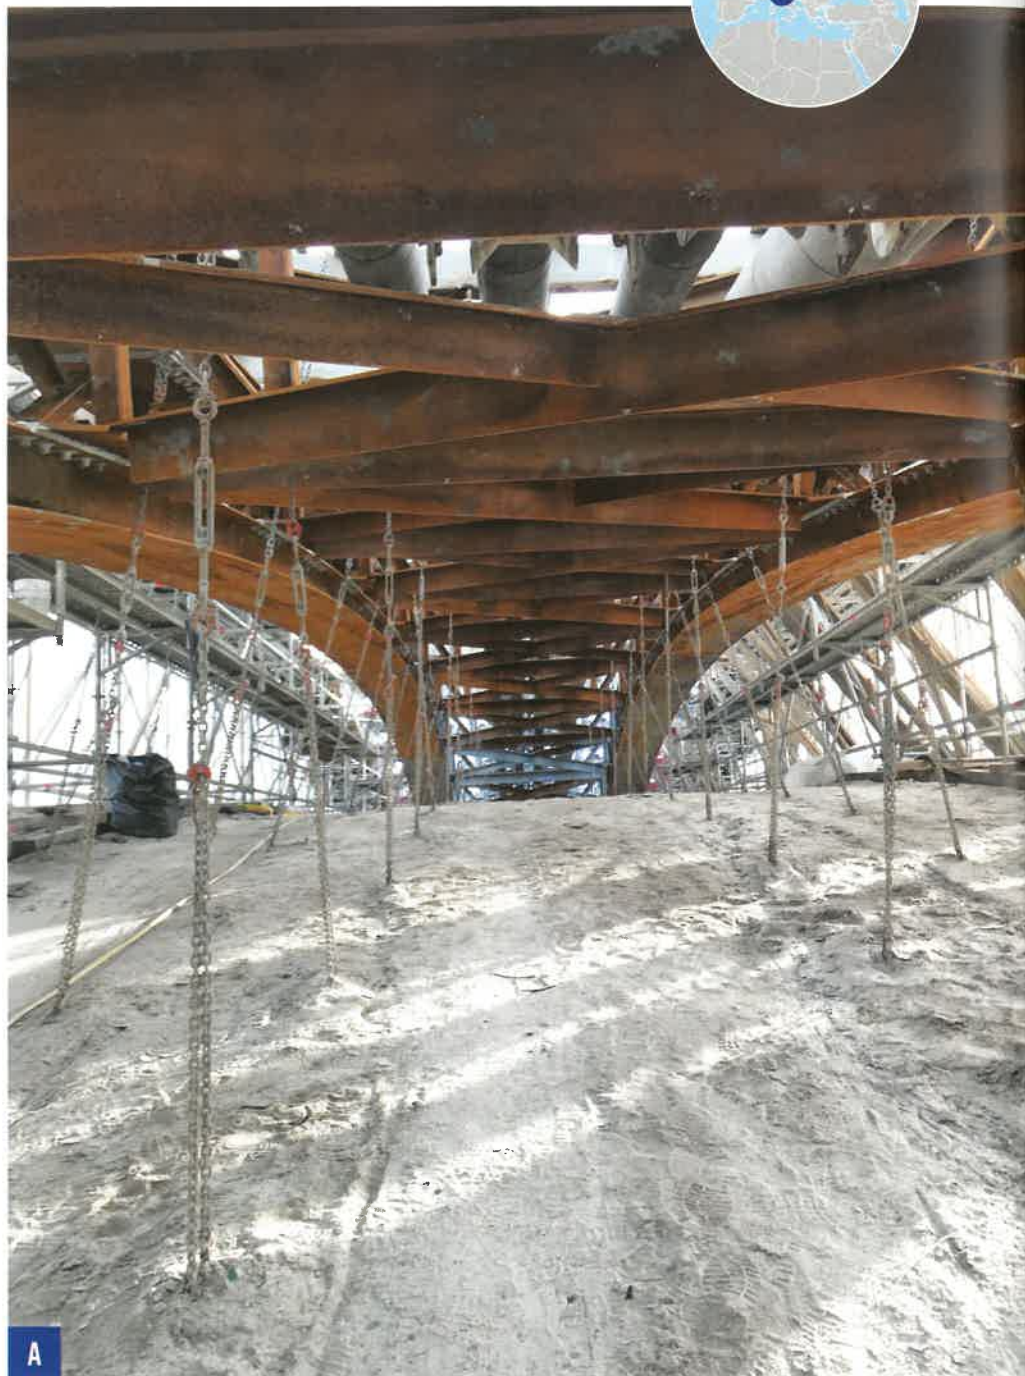
A: The underside of the Academia Bridge.
 B: The steel water pipe system.
 C: Venice's historic Academia Bridge.
 D: Relining taking place within the host pipe.

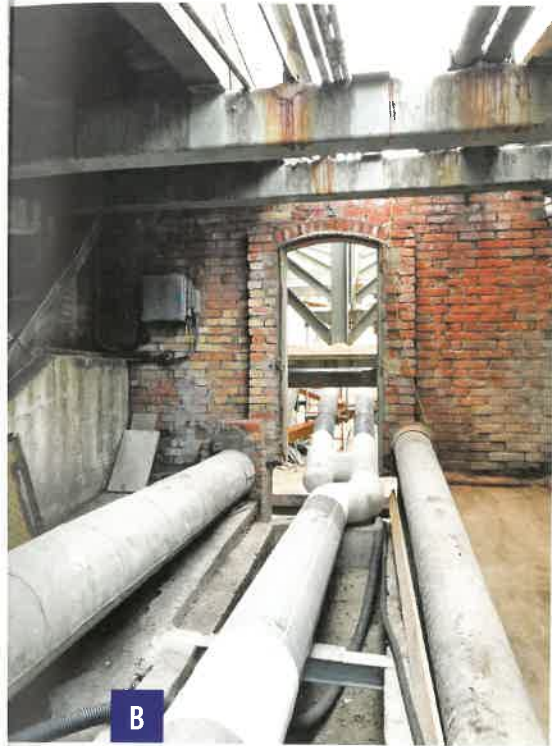
B

During the works, water and wastewater utility Veritas SpA engaged Risanamento Fognature to assist with the rehabilitation of a 70 m section of abandoned steel drinking water pipeline with an outside diameter of 324 mm, operating pressure of 3 bar or lower, in an arched shape with a vent at the top.

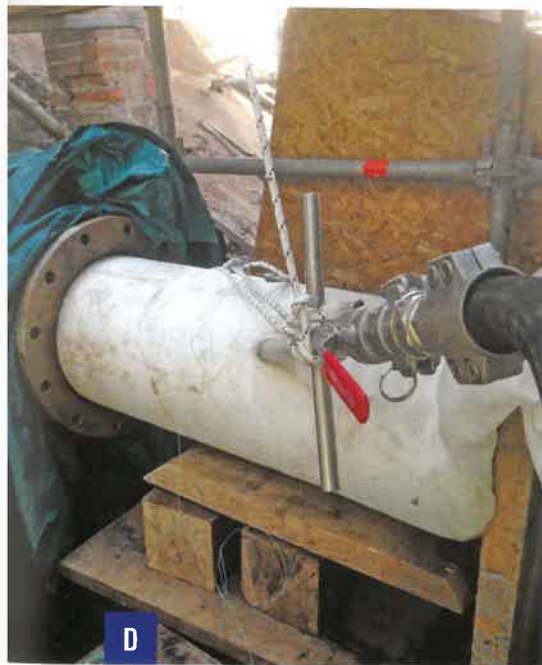
D

From 8am to 7pm, the impregnated liner was inserted into the deteriorated pipe and expanded with steam pressure, fitting it to the

existing pipeline. The system ensured the uniform thickness of the coating, compliance with the original diameter of the pipeline, an increase in hydraulic characteristics and a restoration of great strength and durability.
